Home Inspection Report

Joe Client
1234 Any Street
Gadsden, Alabama 35901

January 3, 2005

Brewster
Home
Inspections

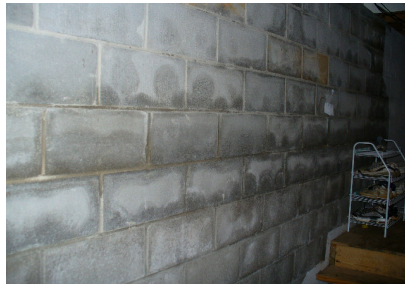
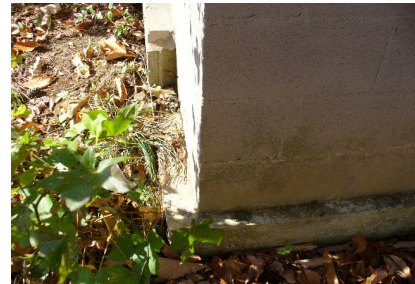
Basement Walls: Functional Except: The block walls are laid on the monolithic slab. The front and west walls are at least 4' to 5' below grade and efflorescence is seen indicating moisture absorption by the walls from the exterior. Basements are usually constructed with the foundation walls on a footing and then the slab is poured within the walls.

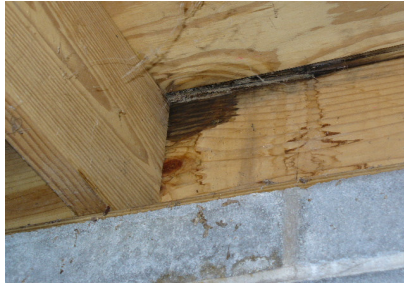
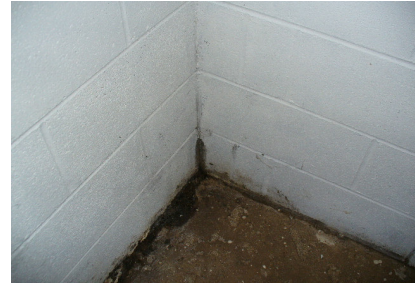
Moisture Intrusion: Efflorescence is seen on the front and south side walls indicating moisture is wicking through the block. No significant volume of moisture intrusion is seen but the inspector can not warrant that future moisture intrusion will not occur. A dehumidifier is operating continuously in the basement.

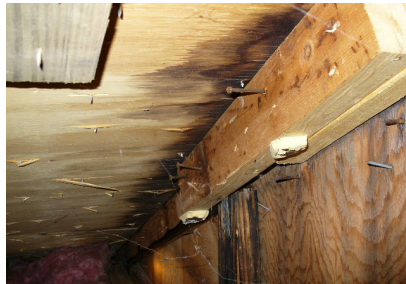
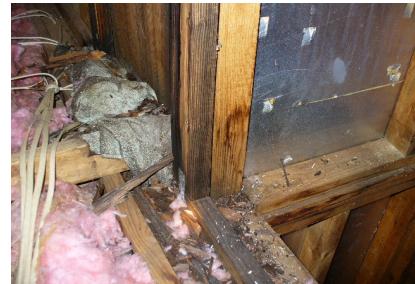
Roof Framing: Functional Except: Recent repairs have been made to the chimney chase due to a previous water leak around the chimney. Evidence of moisture intrusion is seen on the framing but tests within normal limits (10%mc) indicating adequate repairs.

Roof Decking: Functional Except: Old water stains from a previous water leak are seen around the chimney chase. Moisture content was within normal limits (10%). A small section of decking is bowed near the edge on the front exterior.

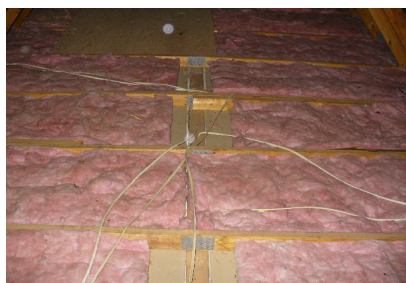
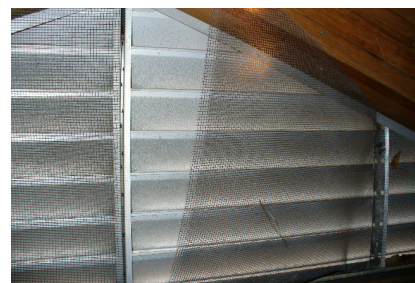
Insulation: Needs Repair: The attic has 3-1/2" of fiberglass batt insulation installed between the trusses. There are areas that do not have insulation installed. Typical standards for attic insulation require at least 10" for in our region. Recommend installing additional insulation.

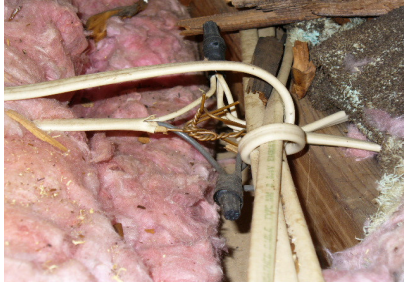
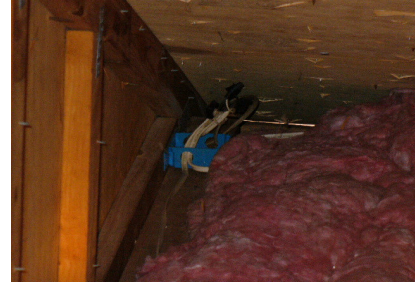
Electrical: Needs Minor Repair/Fire Safety Hazard: There are open wire splices and junction boxes that need covers installed.

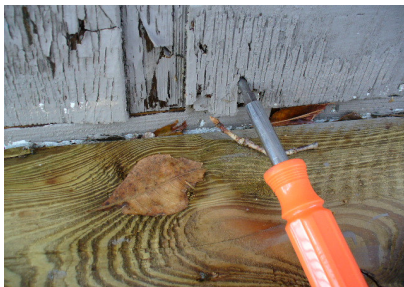
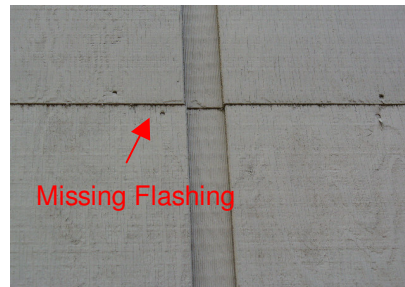
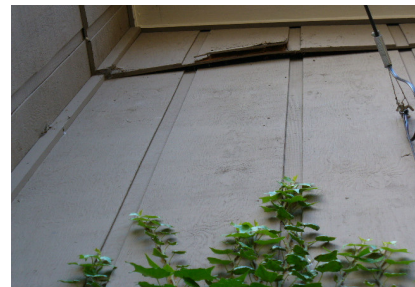
Siding: Needs Repair: The siding has moisture damage near the rear deck surface. These small areas are easily penetrated with a probe and will require replacement in the future. Recommend installing gutters on the rear drip edge to prevent water from splashing onto the siding and further moisture damage. There is not a proper flashing installed between butt joints or where the deck joins the home. These areas need to be caulked/sealed and painted. A small section of siding has been damaged near (above) the electrical service drop.

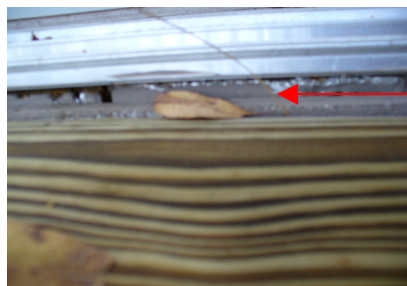
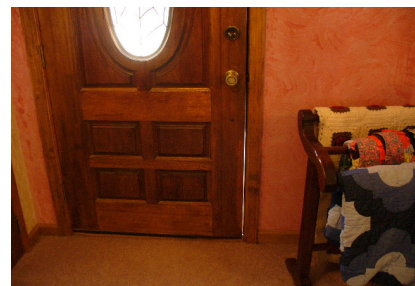
Exterior Doors: Needs Minor Repair: The front entry door has a large gap between the door and the jamb preventing the door from latching/sealing properly. The dining room patio door needs minor alignment to close without rubbing. Neither of the rear patio doors have proper exterior flashing installed beneath the threshold and should be sealed to prevent further moisture intrusion into the subfloor and framing.

Flashing
Absent

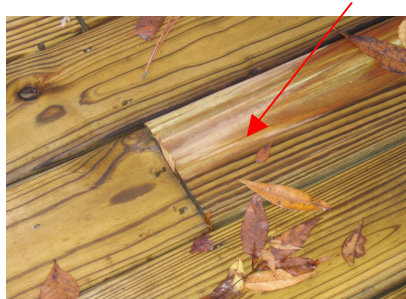
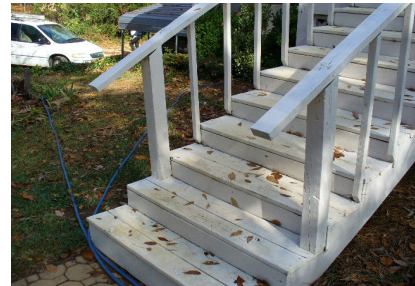
Porch/Deck: Functional Except: The front porch does not have proper baluster spacing of 4" apart. Neither the front porch or rear deck has a flashing installed between the ledger and the siding. This may allow premature moisture damage to the siding and framing. There is at least one deck board (at the dining room end) that needs to be fastened/nailed down.

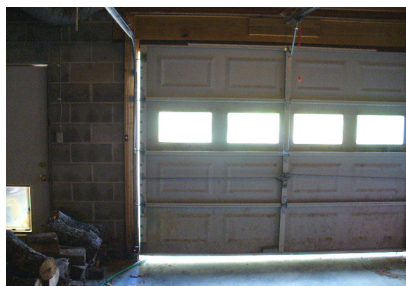
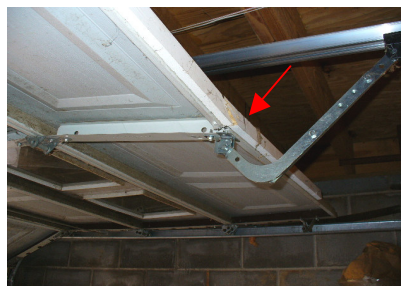
Garage Door: Needs Minor Repair: The top panel of the garage door has minor damage and one of the glass panes is broken and needs replacement. The door does not meet the concrete floor and there is no weather-stripping installed on the exterior. This can allow moisture intrusion during a blowing rain.

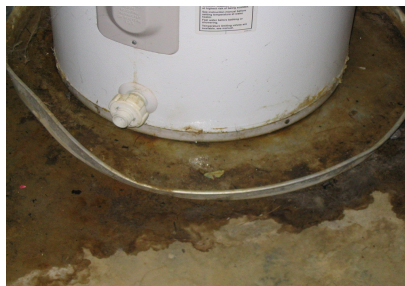
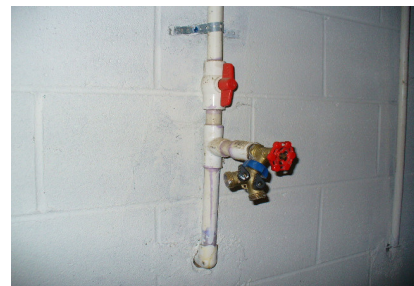
Water Heater: Needs Further Evaluation/Repair: The water heater appears to have a small leak as evidenced by the water in and around the drip pan and the corrosion seen on the base of the tank. Recommend evaluation by a licensed plumber.

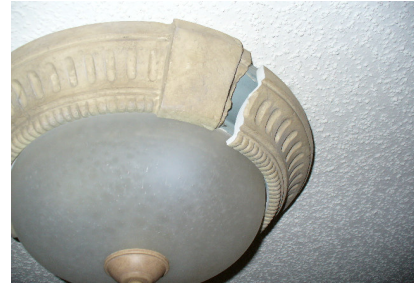
Damaged light fixture in hallway

Light Fixtures: Functional Except: The fluorescent light above the kitchen sink did not function. The light fixture in the hallway is damaged. The light in the master bedroom closet is missing its globe.

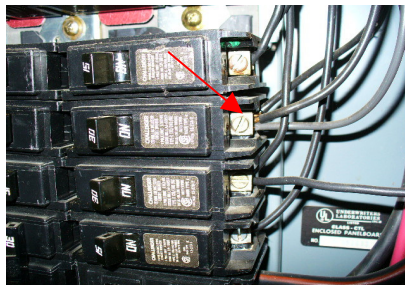
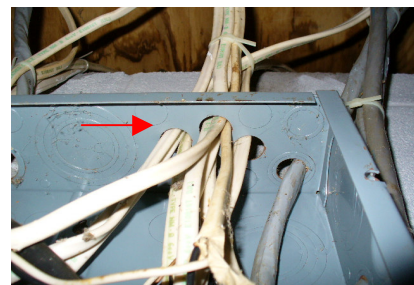
Main Service Panel: Needs Immediate Repair/Fire Safety Hazard: The panel has overfusing (30 amp breakers on 20 amp rated circuits) and double/triple tapping (2 or 3 circuits on one breaker). The branch circuits do not have connectors/bushings installed where they enter the panel. The panel does not appear to have been installed by a professional. The inspector recommends that the panel be repaired by a licensed electrician.

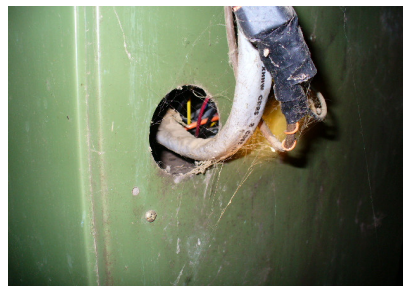
Primary Unit: Needs Minor Repair: The electrical service cable is not installed in a proper connector.

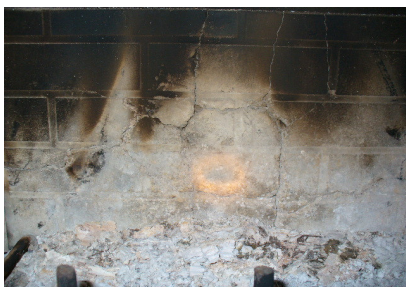
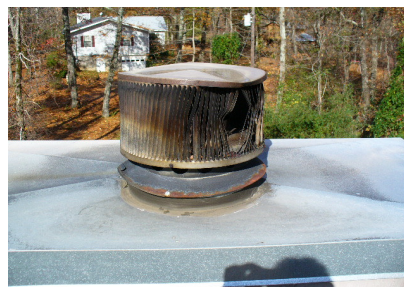
Fireplace: Functional Except: The fire brick is cracked at the back of the fireplace. The stone hearth has missing mortar in the joints.

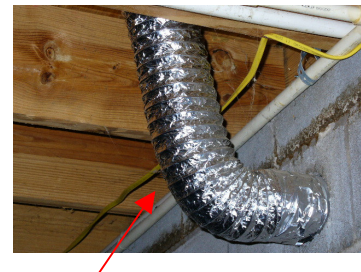
Dryer: Needs Minor Repair: The flexible vent is not approved for dryer venting. Recommend installing a metal (flexible) approved dryer vent.

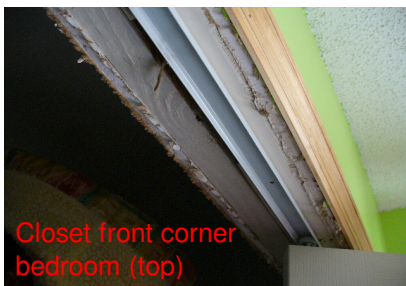
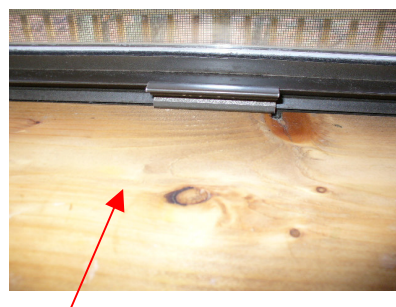
Doors: Functional Except: Most doors need stops installed to prevent damage to the drywall. The front corner bedroom closet doors do not close properly and are not trimmed out professionally. The door to the basement swings out over the stairs which is prohibited by current safety practices.

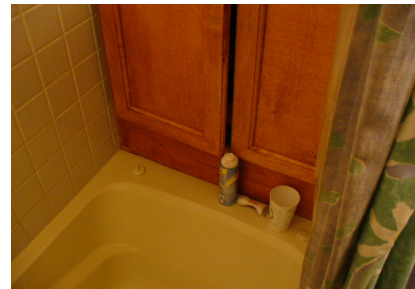
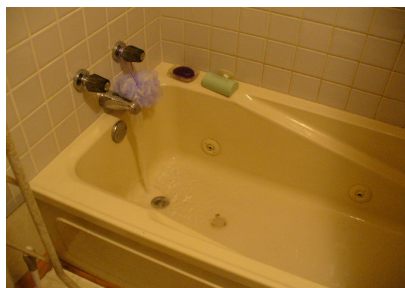
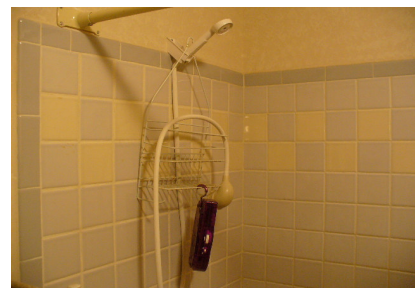
- Walls: Appear Functional.
- Floor: Appears Functional.
- Cabinet: Functional Except: The cabinet behind the tub could sustain water damage if the shower curtain is not used properly.
- Sink: Appears Functional. The drywall has a large cut out for the water supply pipes which could allow unconditioned air to enter the cabinet/interior.
- Commode: Appear Functional.
- Tub: Needs Repair: The pump motor did not function for the whirlpool.
- Ventilation: None Present: The inspector recommends installing a ceiling exhaust fan to remove excess moisture from bathing.
- Electrical: Functional Except: The inspector recommends installing GFCI receptacles in bathrooms to prevent a shock hazard.
